Manhole Inspection Summary

Manhole # S67Y__017MH

Insp Date: **12/15/08 10:38 AM**

Location Address: **6200 Beckley St.**

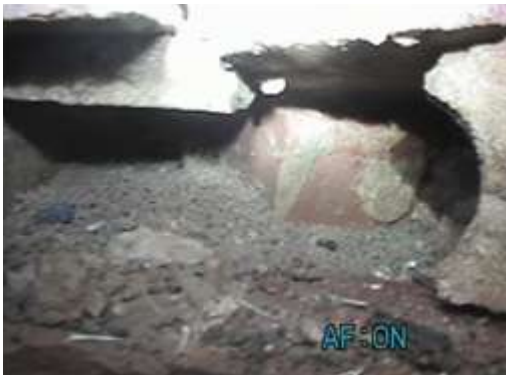
Defect 1

Loose bricks under frame

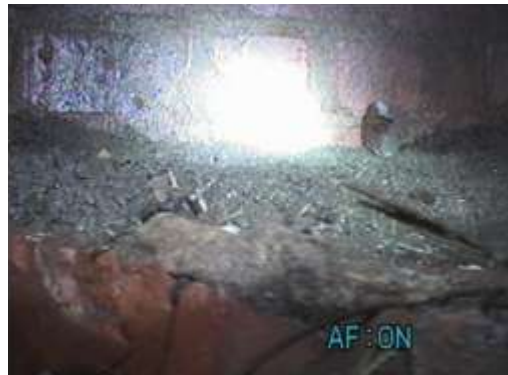
Defect 2

Debris on bench

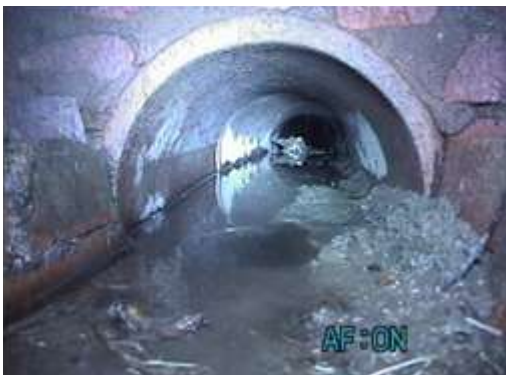
Defect 3

Debris in channel

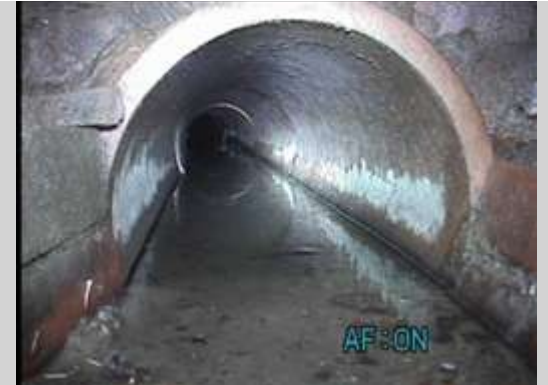
12 O'Clock Outflow

10 in. Circular Gravity Sewer
Pipe Out @ 12 O'Clock

Pipe Height: **9.6** (in.) Rod and Bar (Angled)
Pipe Material: **Clay** ☐ Pipe Lined
Invert Depth: **7.92** (ft.) Flow Characteristics: **Slow**
Deposits: ☐ None ☐ Mud ☒ **Sludgy** ☐ Debris ☐ Grease
Silt Depth: **1** (in.) Deposits Extent: **Medium**
Infiltration: **None** Pipe Seal Cond: **Sound**

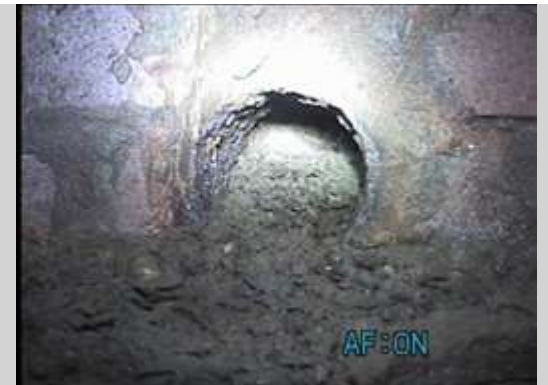
5 O'Clock Inflow

4 in. Circular Gravity Sewer
Pipe In @ 5 O'Clock

Pipe Height: **3.6** (in.) Rod and Bar (Angled)
Pipe Material: **Clay** ☐ Pipe Lined
Invert Depth: **7.25** (ft.) Flow Characteristics: **None**
Deposits: ☐ None ☒ **Mud** ☐ **Sludgy** ☐ Debris ☐ Grease
Silt Depth: **1** (in.) Deposits Extent: **Heavy**
Infiltration: **None** Pipe Seal Cond: **Sound**

Connects To: **Stub connection / abandoned**

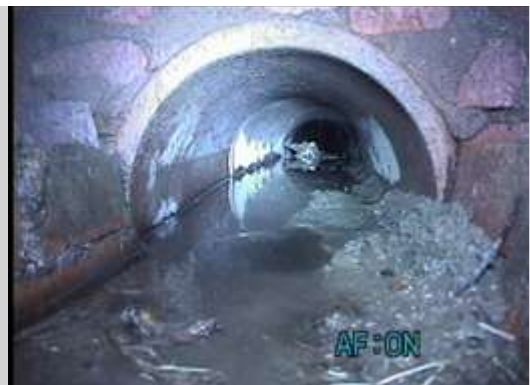
6 O'Clock Inflow

10 in. Circular Gravity Sewer
Pipe In @ 6 O'Clock

Deposits: ☐ None ☐ Mud ☒ **Sludge** ☐ Debris ☐ Grease

Silt Depth: **1** (in.) Deposits Extent: **Medium**
